# **Construction OS&H for workers**

## **Action plans & conclusions**

## Concluding case study

The case study is the collapse of the side of an excavation for a large building project, which killed eight people (seven on site and one later in hospital).

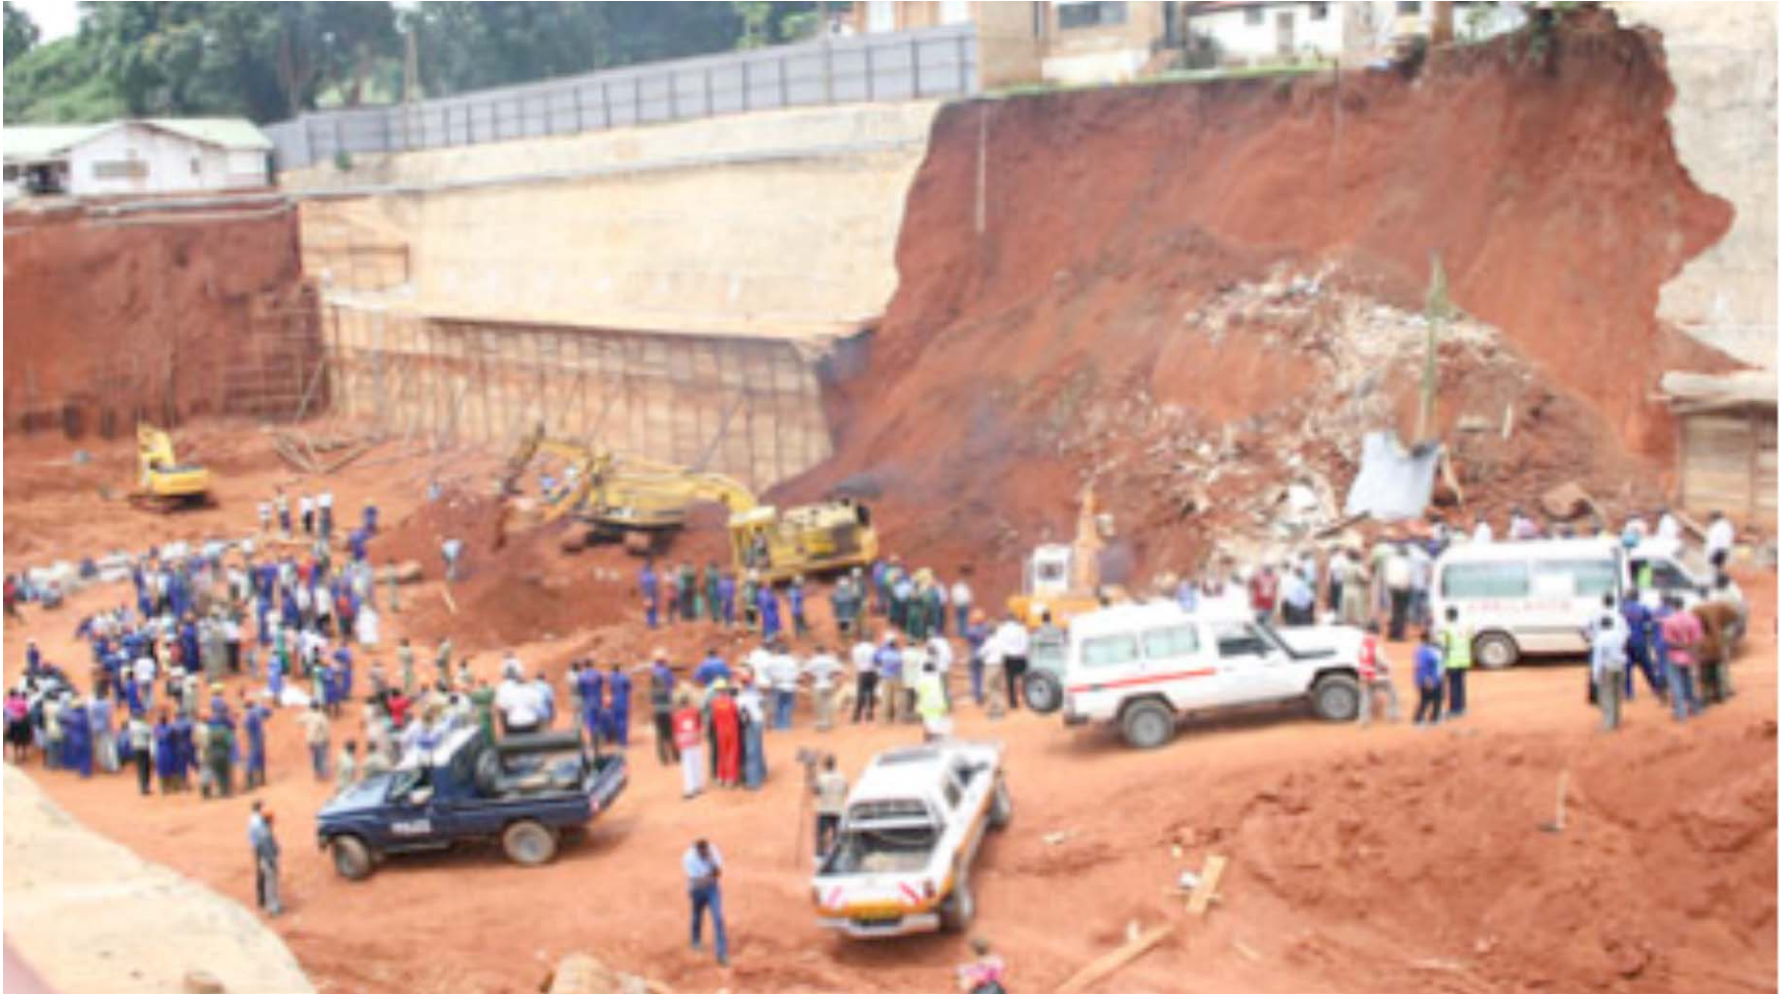
# The collapse

The plot comprising of the site had been excavated to nearly 100%.

The excavation is about 15m deep and nearly vertical.

Most parts of the excavation base up to the height of about 7m were supported by strutting of metal and wood.

In addition, the rest of the excavation above the strutting had a plaster covering of about 2 inches (as viewed at the point of collapse).

At the western part there seemed to have been a previous cave-in, downing part of the site offices, as cleavage markings were observed from the site office structure.

Near to the accident point was an excavator with fresh marking on the ground; an indication that it was in use probably at the time of the accident occurrence. Above the accident point was a house that also caved into the site with the soil cave-in.

The presence of a house is an indication of disturbed ground and the water run-off from the house enabled water percolation in the ground which could have been compounded by the rainy season.

An excavation of such magnitude could have been undertaken progressively i.e. section by section proceeded by strutting and backfilling.

Previous cave-in at the site was an indication of poor methods of work.

The methods of excavation protection were inadequate and did not provide protection to the ground level.

Excavator vibrations at the time of the accident could have triggered the event.

This is a clear case of inadequate support to a major excavation, and also failure to take due care not to make it even more unsafe by restricting the movement of plant and equipment at the surface near to the excavation. No realistic hazard and risk analysis or method statement would have allowed this excavation to proceed in this way.

If the deep basement was necessary, the designers may have considered the use of such construction methods as contiguous piling, which supports the ground while constructing the wall, reducing the need for working space which reduces the excavated volume, so offsetting the cost to some extent.
